Re: Notice of Violation (NOV)
 Compliance Evaluation Inspection
 Arlington STP
 NPDES Permit No. TN0078603
 Shelby County

Compliance Inspection for Individual NPDES Permit

Facility Name: Arlington STP	NPDES Tracking Number: TN0078603
Permit Effective Date: January 1, 2013	Permit Expiration Date: November 30, 2017
Date and Time of Inspection: 11/15/2016, 11/16/2016 and 11/17/2016	Inspector Name: Eddy Bouzeid
Official Contact Person Name: Mike Wissman, Mayor	
Address: P.O. Box 507, Arlington, TN 38002	Phone Number: (901) 867-2620
	Email: mwissmanjr@comcast.net

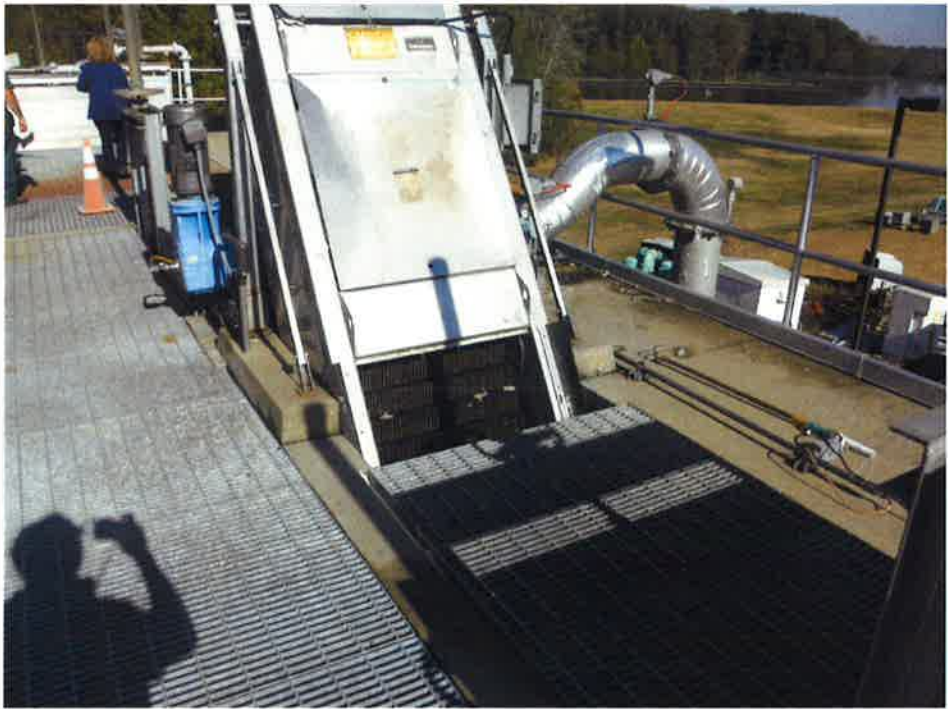
Description View of the bar screen at the headwork.			
Photo No. <div style="text-align: center; border: 1px solid black; width: 40px; margin: 0 auto;">2</div>	Date <div style="text-align: center; border: 1px solid black; width: 100px; margin: 0 auto;">11-15-2016</div>

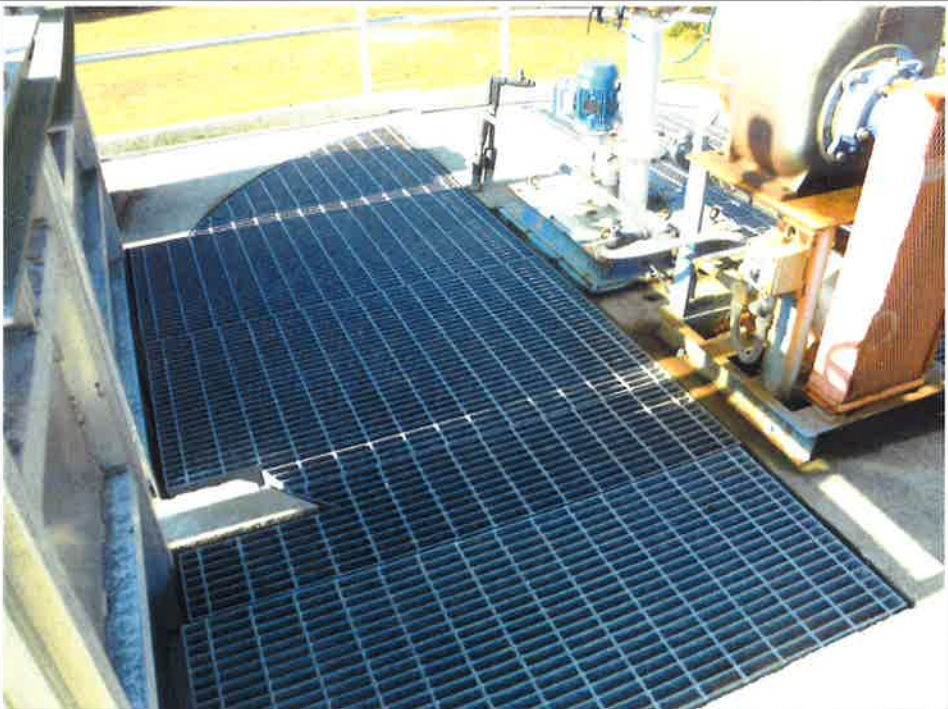
Description View of the grit chamber at the headwork.

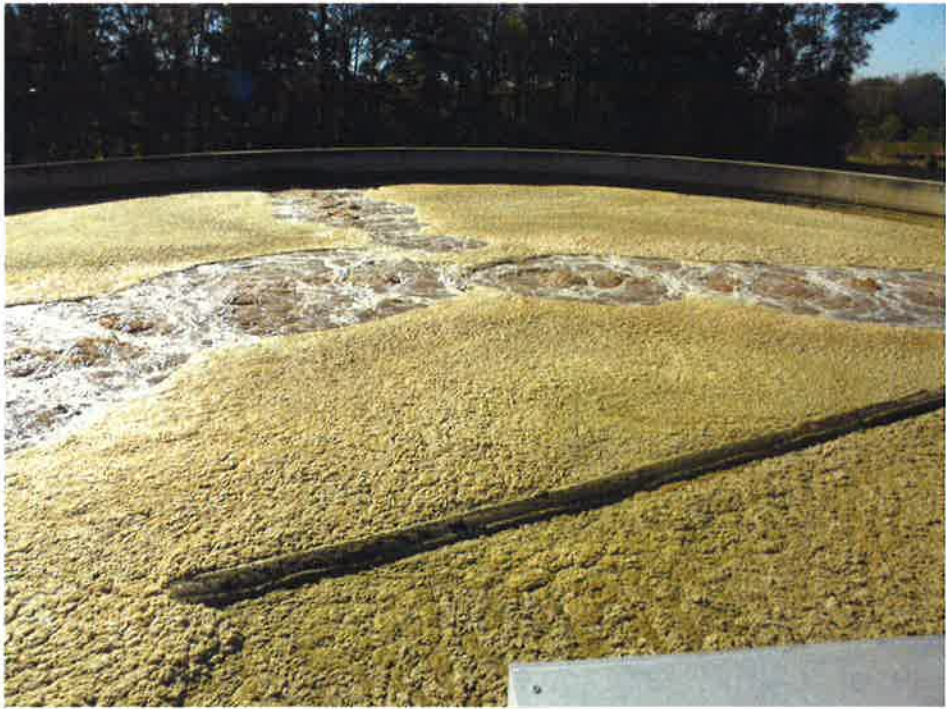
Facility Name: Arlington STP		Site Location: Arlington, Shelby County	Tracking No.: TN0078603
Photo No. 3	Date 10-15-2016

Description View of the SBR basin during intensive aeration.			
Photo No. 4	Date 10-15-2016

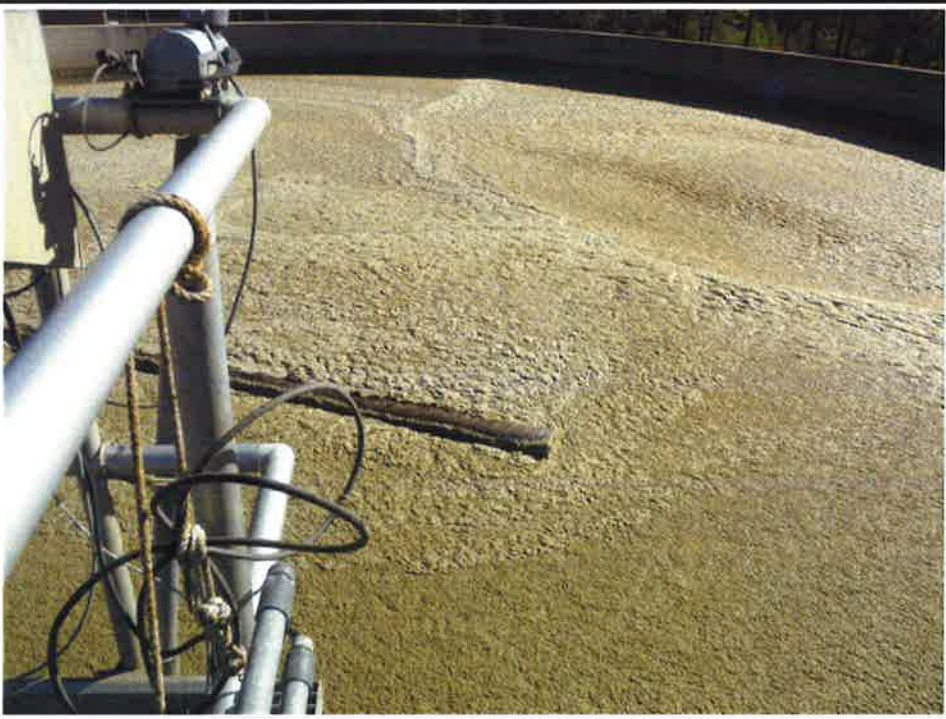
Description View of the SBR basin during settling period.

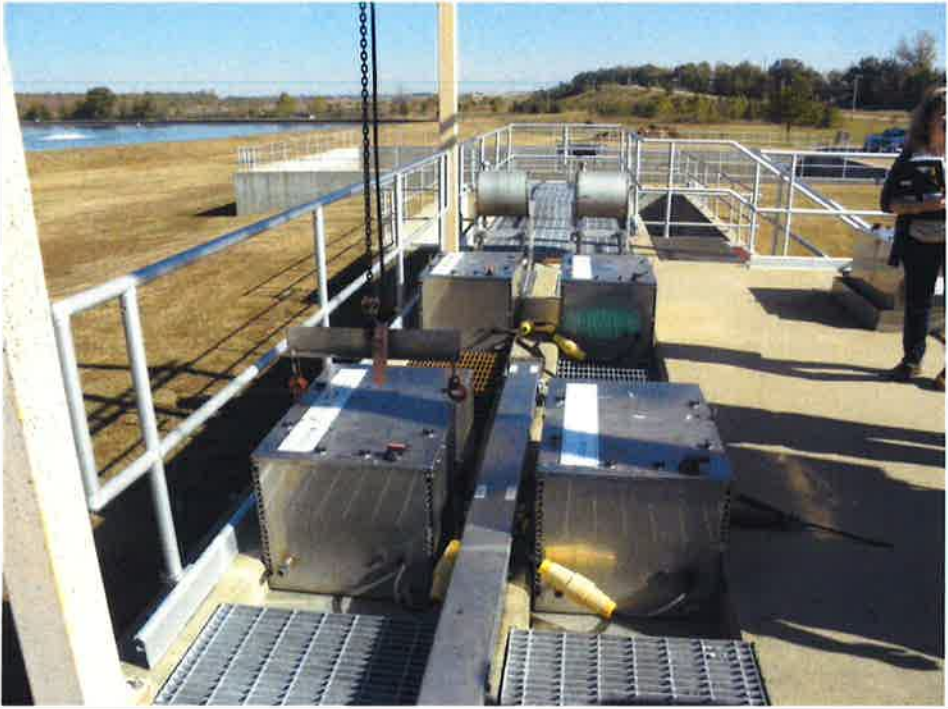
Facility Name: Arlington STP		Site Location: Arlington, Shelby County	Tracking No.: TN0078603
Photo No. <div style="text-align: center;">5</div>	Date <div style="text-align: center;">10-15-2016</div>

Description View of the ultraviolet lights disinfection area.			
Photo No. <div style="text-align: center;">6</div>	Date <div style="text-align: center;">10-15-2016</div>

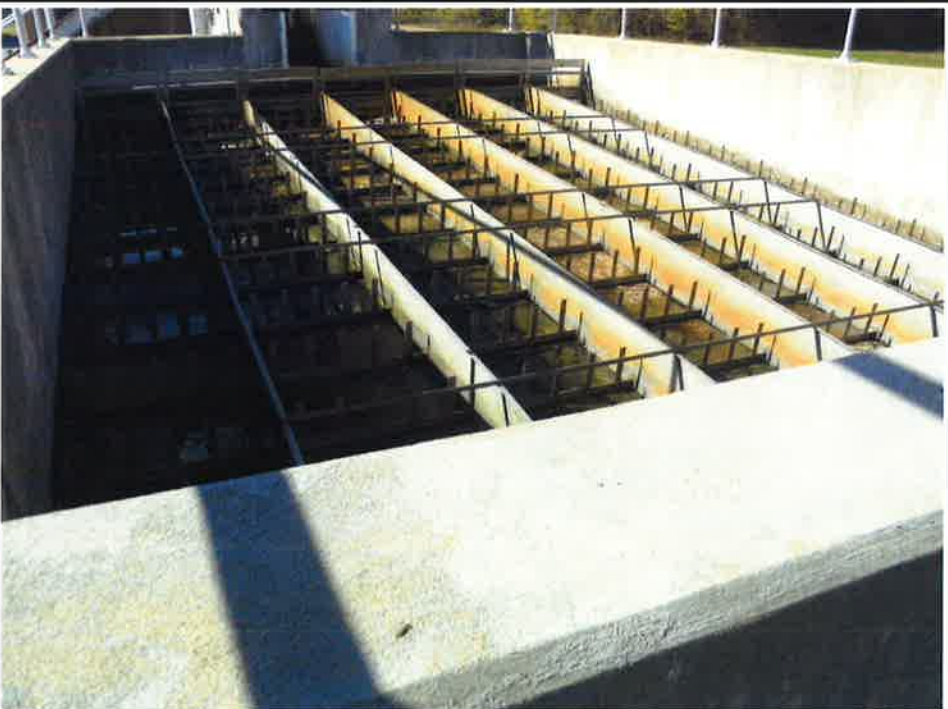
Description View of the cascade system to enhance the dissolved oxygen.

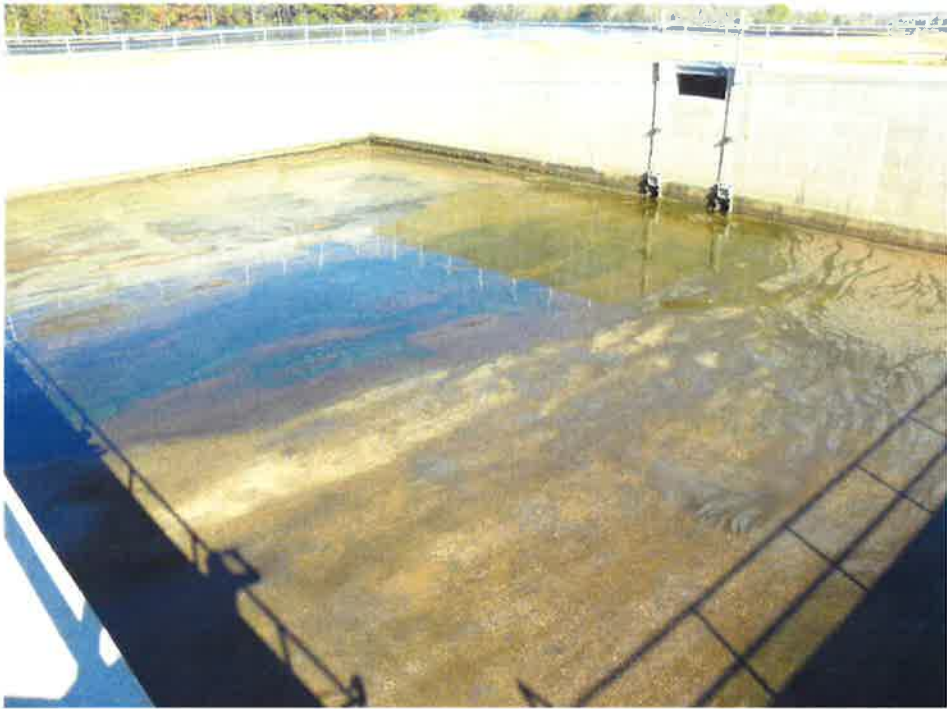
Facility Name: Arlington STP		Site Location: Arlington, Shelby County	Tracking No.: TN0078603
Photo No. 7	Date 10-15-2016

Description View of the surge basin.			
Photo No. 8	Date 10-15-2016

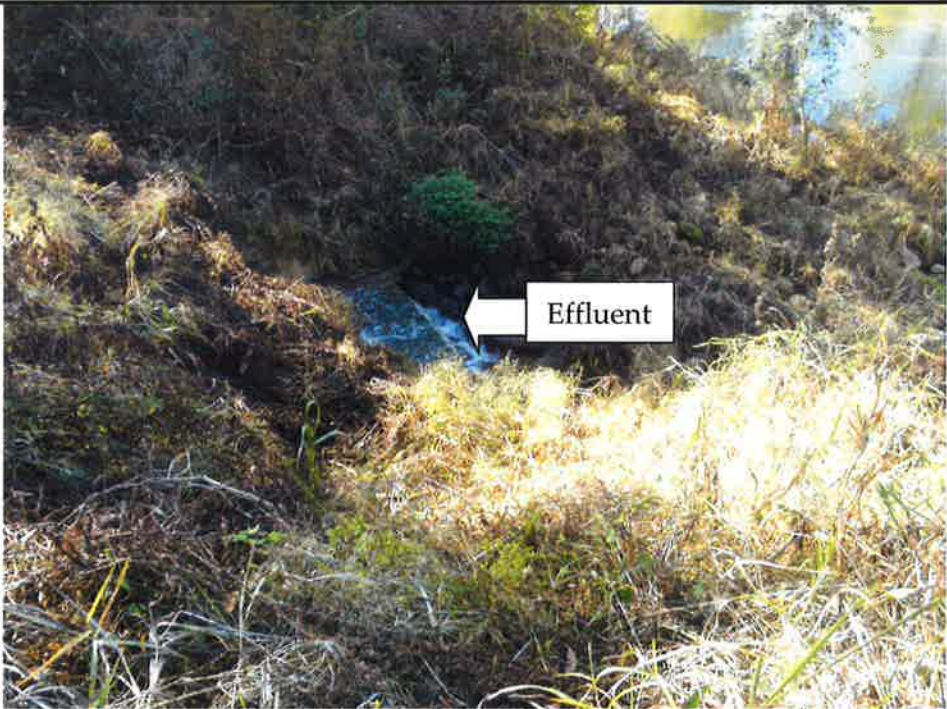
The effluent was clear at the discharge point to the Loosahatchie River (photo 8). The sign was in place at the point of discharge to the River (photo 9). The information on the sign was correct.

Description View of the effluent at the discharge point to the Loosahatchie River. The effluent was clear at the time of the inspection.

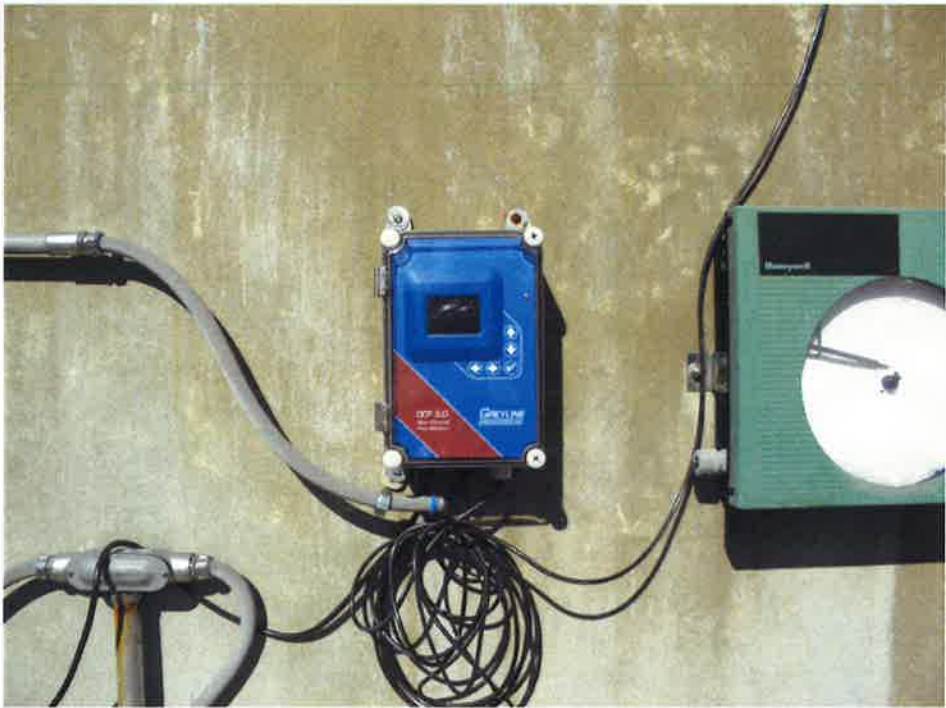
Facility Name: Arlington STP		Site Location: Arlington, Shelby County	Tracking No.: TN0078603
Photo No. 11	Date 10-15-2016

Digital flow meters were installed at the influent and effluent (photos 10 & 11). The flow meters appeared to be operating correctly during the time of the inspection. The devices are also calibrated annually by an independent contractor, New Water Systems LLC, located at P.O. Box 193805, Little Rock, AR 72219. The last calibration by New Water Systems was conducted on November 2, 2016. Certification of the calibration was available for review at the plant.

Description View of the effluent digital flow meter.			
Photo No. 12	Date 10-19-2016

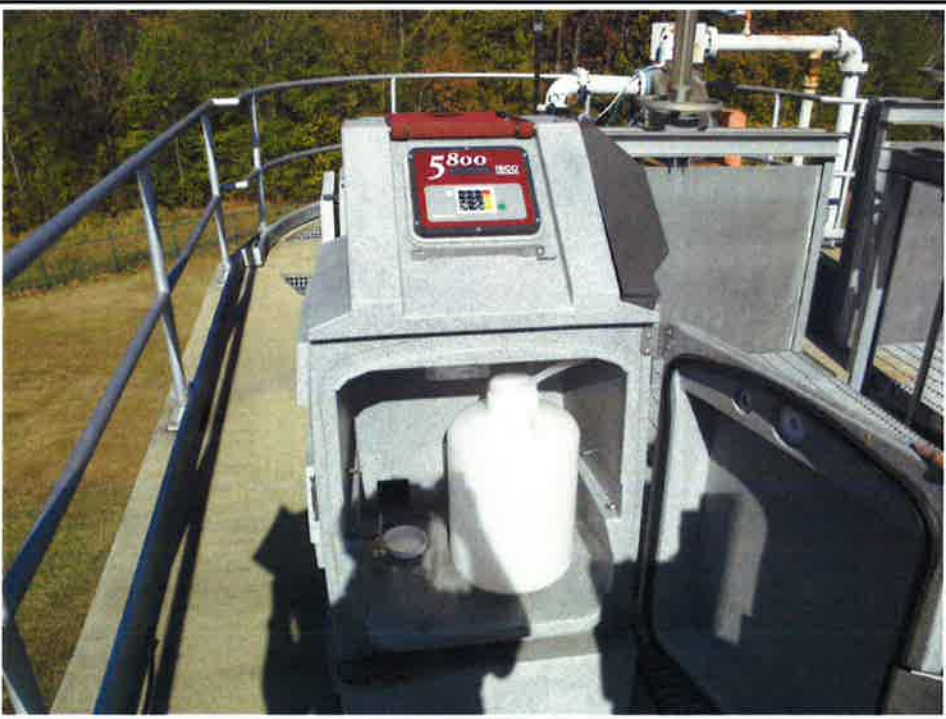
The Arlington STP uses automatic flow proportional samplers on the influent and effluent (photos 12 & 13). However, due to the nature of the SBR, which is considered a batch discharge system, it is not feasible to collect a flow-proportionate sample from the batch

7. Sampler strainers were observed to have accumulated debris on the strainers, which could produce erroneous sample results. The strainers need to be cleaned daily.

Description View of the influent composite sampler.

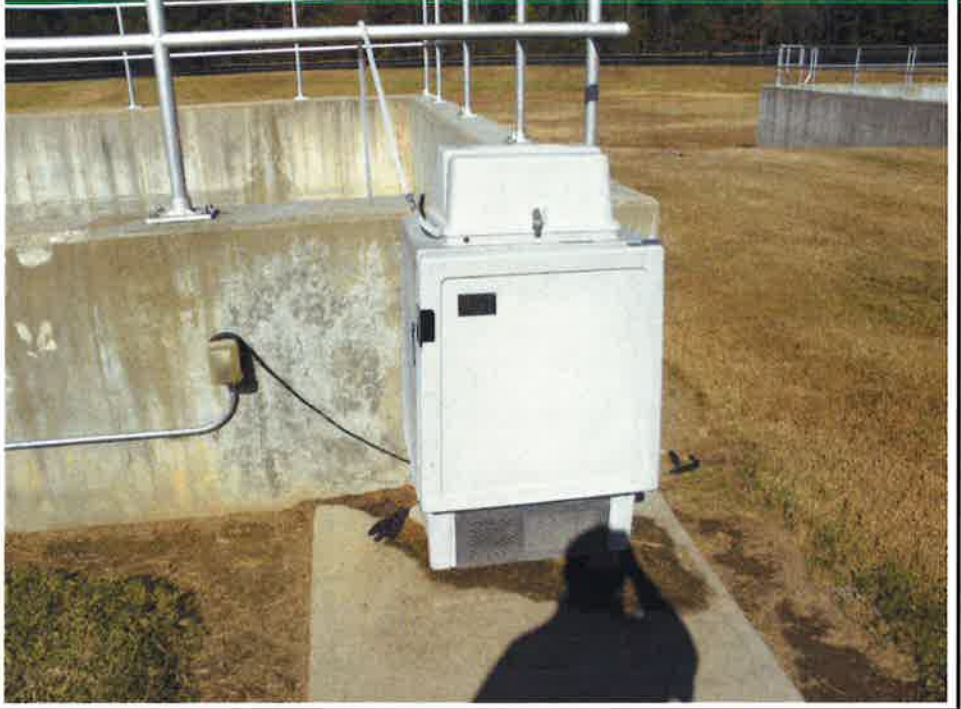
Facility Name: Arlington STP		Site Location: Arlington, Shelby County	Tracking No.: TN0078603
Photo No. 13	Date 10-19-2016

Description View of the effluent composite sampler.
